## Fracture of fully hydroxyapatite-coated titanium femoral stem of a total hip replacement—a report of 3 cases

Dinesh K Sharma<sup>1</sup>, Stuart Brooks<sup>1</sup>, Stuart Creasey<sup>2</sup> and Brian Lewis<sup>2</sup>

<sup>1</sup>Birmingham Heartlands & Solihull (Teaching) Hospitals, Birmingham, <sup>2</sup>Materials Research Institute, Sheffield Hallam University, Sheffield, UK

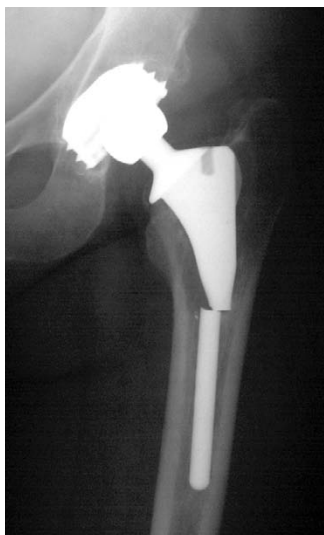
asymptomatic but at review 3 years after surgery, a routine radiograph showed a fracture of the femoral stem (Figure 1). Revision was done (using the same stem design) to stem size 11.

All 3 patients had also had a JRI total hip replacement in their contralateral hip without problems. In all 3 cases, radiographs showed osteolysis proximally and the fracture just distal to the cone of the femoral stem. These stems were subjected to metallurgical analysis

Figure 1. Fracture of femoral stem.

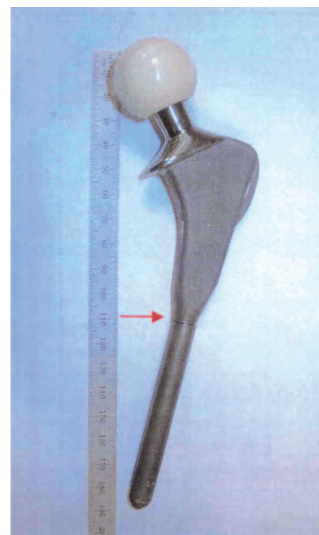
All 3 components were retrieved using a hole in the intermedullary canal made distal to the tip of the femoral stem. In each case, the proximal component was loose with osteolysis and had lost all evidence of the hydroxyapatite coating. The distal part of each prosthesis was bonded firmly to the bone. This, in turn, was the cause of difficult revision as it was first separated from the medullary canal by bone gouge and was then removed by punching the component proximally. There was no evidence of infection in any of the cases, based on cultures or clinical assessment.

Figure 2. The failed stem as it was received, with the location of the fracture indicated by the arrow at the top of the distal tip. The hydroxyapatite (HA) coating was shown to be lost, which was thought to be due to an infection that generates environmental conditions conducive to dissolution of the coating.

EDX analysis was carried out on features of interest such as foreign particles and coating material. It was concluded that failure of the stem at the top of the distal tip was by a mechanism of fatigue. Most of the fracture surface exhibited low material deformation which is associated with fatigue. An initiation site was observed at the surface, which had associated cracking. The presence of fine secondary cracks and fine striation marks (Figures 2 and 3) found on the fracture surfaces also supports

Hydroxyapatite coating of a femoral component may become a significant problem if the proximal part of the femoral component fails to osteo-integrate, causing excess loading on the distal part of the femoral component. This causes subsequent metal fatigue and fracture, leading to difficult surgical revision. We believe that further consideration needs to be taken as to whether a femoral stem should be fully hydroxyapatite-coated or hydroxyapatite-coated only proximally.

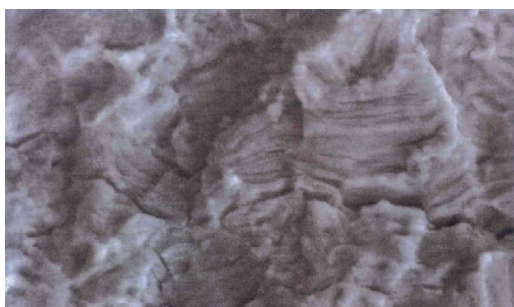
Figure 3. High-resolution SEM image of the fracture surface taken at the central region, where both fine fatigue striations and a number of secondary cracks were evident.

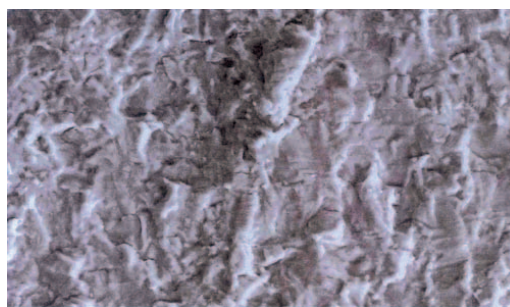
Figure 4. SEM image close to the final failed region, still showing some evidence of fine fatigue striations. This region is generally associated with overload failure, as the stem can no longer support the stresses acting upon it.
