# Catastrophic failure of 4 cobalt-alloy Omnifit hip arthroplasty femoral components

Li-On Lam<sup>1</sup>, Karl Stoffel<sup>1</sup>, Alan Kop<sup>2</sup>, and Eric Swarts<sup>2</sup>

**Background** Femoral component neck fracture is an uncommon type of failure in total hip arthroplasty. We present a report on 4 retrieved cobalt-chrome femoral components that fractured at the neck, where we investigated the mechanisms of failure.

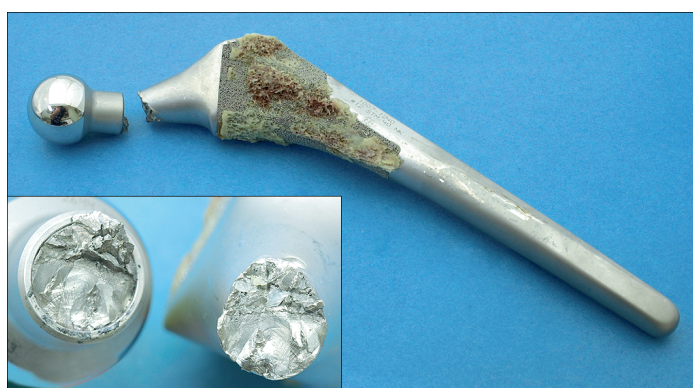
Figure 1. Macro photograph of fractured stem. Insert shows surface of fracture.

lar heads. In all cases, the fractures had occurred immediately adjacent to the base of the modular head (Figure 1). Both surfaces of the taper of head and neck showed evidence of crevices and intergranular corrosion.

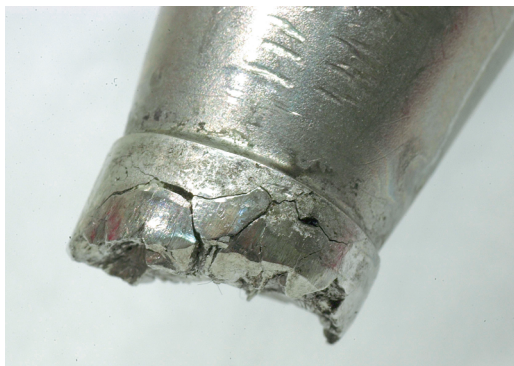
All the fractures had started at the superior tensile surface of the neck adjacent to the femoral head stem junction (Figure 2). Fractography with scanning electron microscopy revealed that the ultimate cause of failure had been initiated by intergranular corrosion, crack growth through fatigue, and catastrophic failure subsequent to tensile overload. Microstructural analysis revealed a coarse grain structure with grain sizes up to 8 mm in length (ASTM E112-96, 2004) and the presence of grain boundary carbide precipitates (Figures 3 and 4).

Figure 2. Intergranular cracking on the superior tensile surface of the trunnion. Note the large grains.

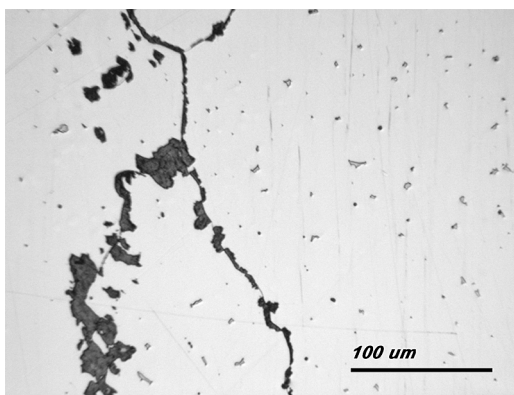
Figure 3. Extensive carbide precipitation at the grain boundary.

Poor microstructures, featuring extensive carbide precipitation at the grain boundaries, have been implicated in the fracture of cobalt-chrome devices (Swarts et al. 2001). Carbide distribution is important in the failure of cobalt-chrome stems in at least three ways. Firstly, carbides may act as crack-like discontinuities on the surface of the stem. Secondly, they present an easy crack path. Finally, and most importantly in the present failures, is the concentration of carbon in the carbides—which has an effect on the localized corrosion potential, leading to preferential attack at the grain boundaries and inter-dendritic regions where the carbides precipitate.

This report is the largest series of fractures in the neck region of uncemented cobalt-alloy femoral components that we are aware of. In light of our findings, attention should be paid to the manufacturing process—as we believe that the structure of the device could be improved by introducing a solution-annealing step that would help to prevent intergranular carbide precipitation. We also advise caution when using a skirted head in combination with a device of suboptimal microstructure.

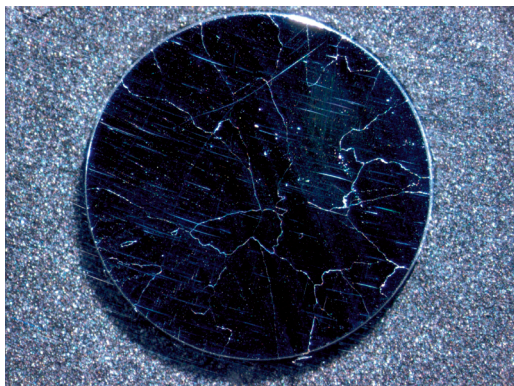
Figure 4. Macrostructure of a cross section taken through the neck of a fractured stem. Note the large grains and the presence of precipitates at the grain boundaries.

Suboptimal macro- and microstructure of the implants also predisposed them to failure. Macroscopically, we found that the grain size was large.

Grain size is a factor that has a direct effect on the fatigue life of an orthopedic device. In general terms, the larger the grain size, the lower the materials yield and fatigue strength. Microscopically, the extensive carbide precipitates along the grain boundaries also predispose the device to failure.
