Early bead shedding of the Vitalock acetabular cup – a report on 7 cases

Gaston Slullitel, Alejandro González Della Valle, Martín Buttaro and Francisco Piccaluga

Department of Orthopaedics, Hospital Italiano de Buenos Aires, Argentina

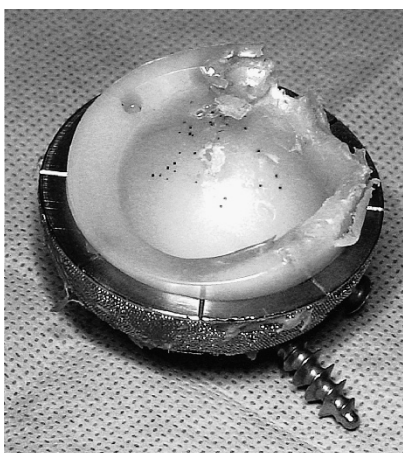
We are particularly concerned about the beads detected in the periarticular soft tissues of 2 patients. They can be sources of third body wear if entrapped in the articulating surfaces (Figure 2). Moreover, gradual bead shedding may jeopardize cup fixation by ingrowth and provide a pathway for polyethylene wear migration.

Figure 2. Extensive bead embedding in the polyethylene articular surface of a porous acetabular component of a different design.
